Hacienda Inspectors
401 N Rock St.
Gilbert, AZ 85234

Building Inspection Report

893 W Main St.
Mesa, AZ 85205-

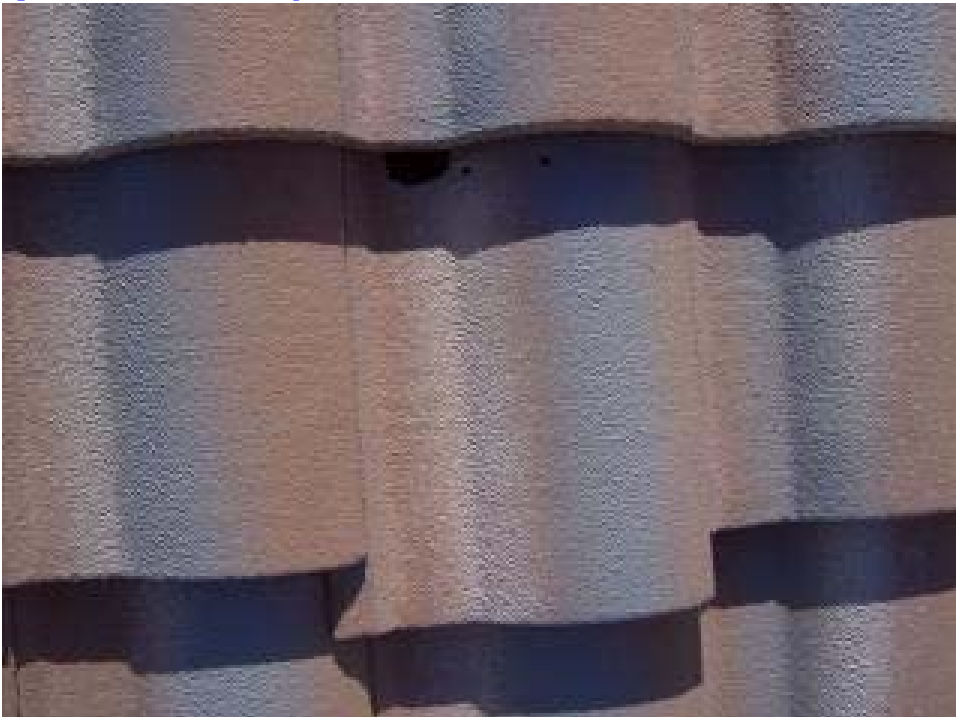
1. House & Garage Roof Surface Material: Concrete tile Loose or damaged tiles or shingles, A qualified roofing contractor is recommended to evaluate and estimate repairs

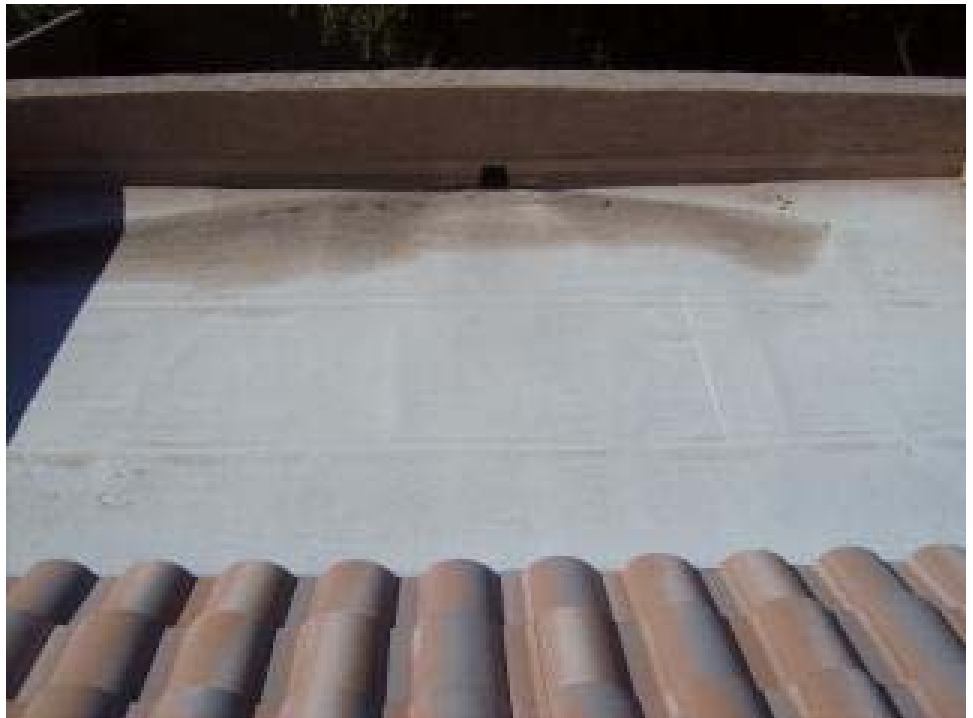
2. **Patio Roof Surface Material:** Rolled roof material, Coated
Maintain roof material on a regular basis, Consult a qualified roofer

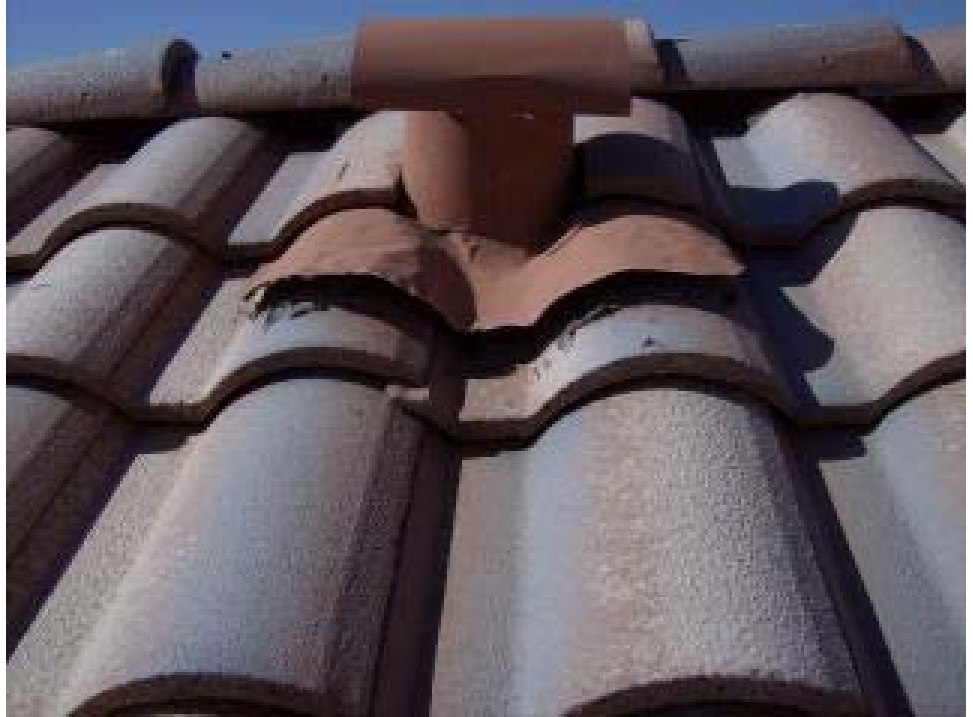
3. **Flashing:** Galvanized Loose &/or lifting flashing(s), need resealing

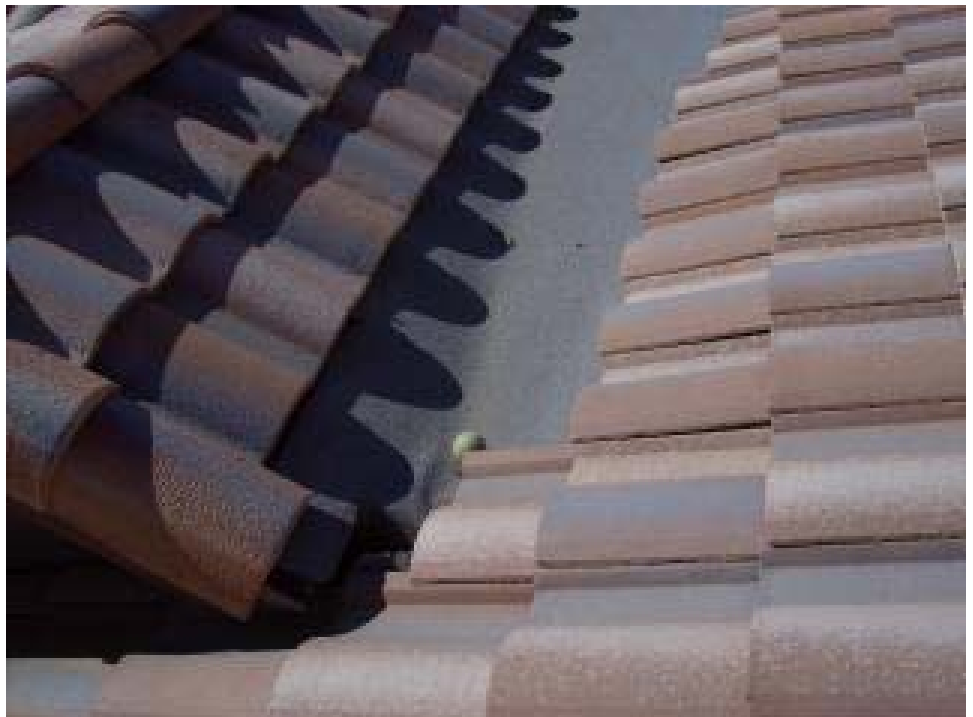
4. **Valleys:** Preformed metal, Rolled roof material Maintain roof material on a regular basis, Consult a qualified roofer

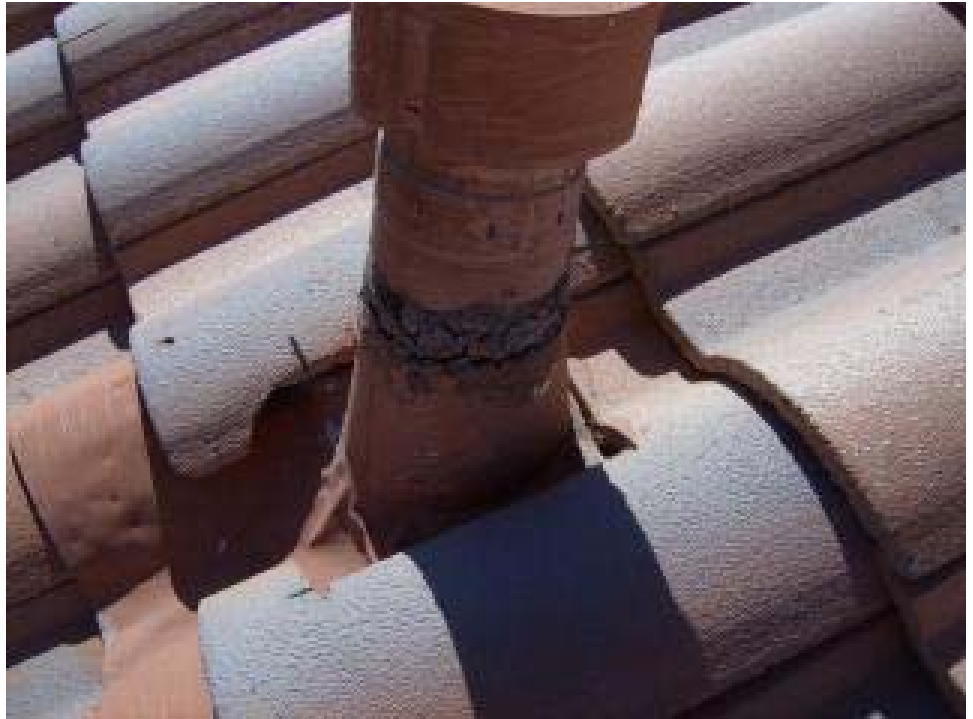
5. **Gas flue pipes** Double walled "B" vent One or more gas flue pipes is missing a storm collar, Recommend repair by a qualified technician

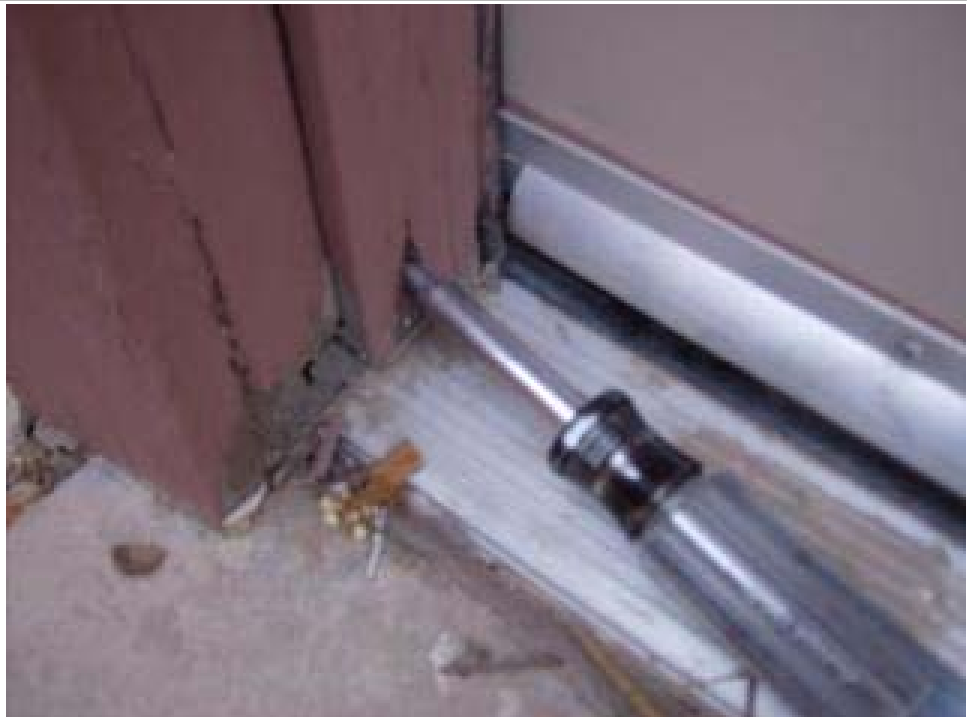
6. **Trim: Wood** Wood rot- garage service door trim, A qualified contractor is recommended to evaluate and estimate repairs

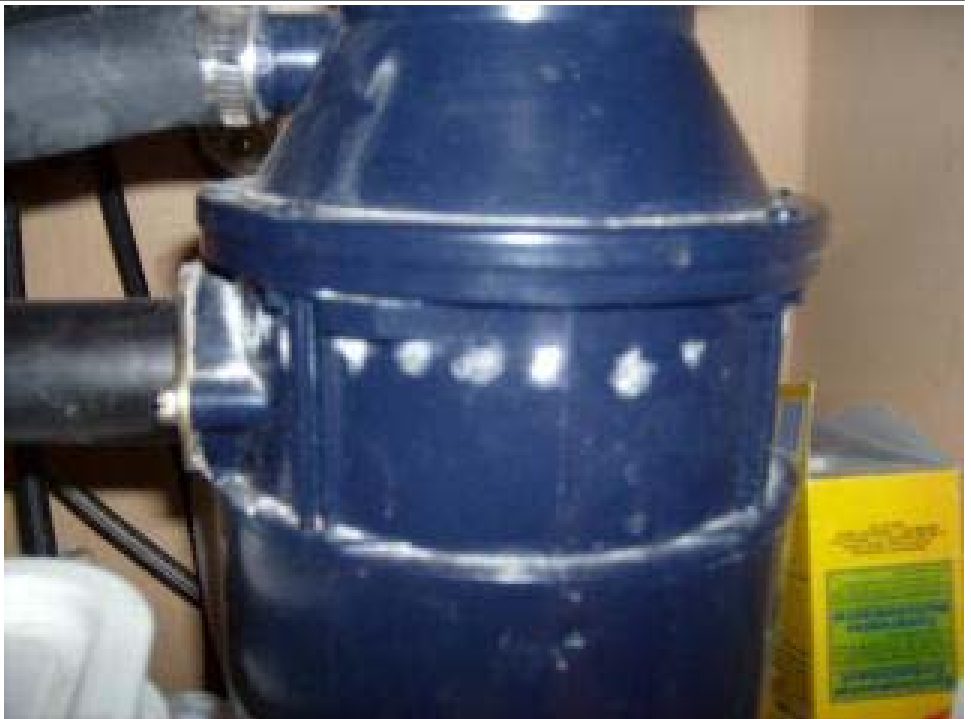
7. Kitchen Kitchen Disposal: XXX
Corroded but not currently
leaking

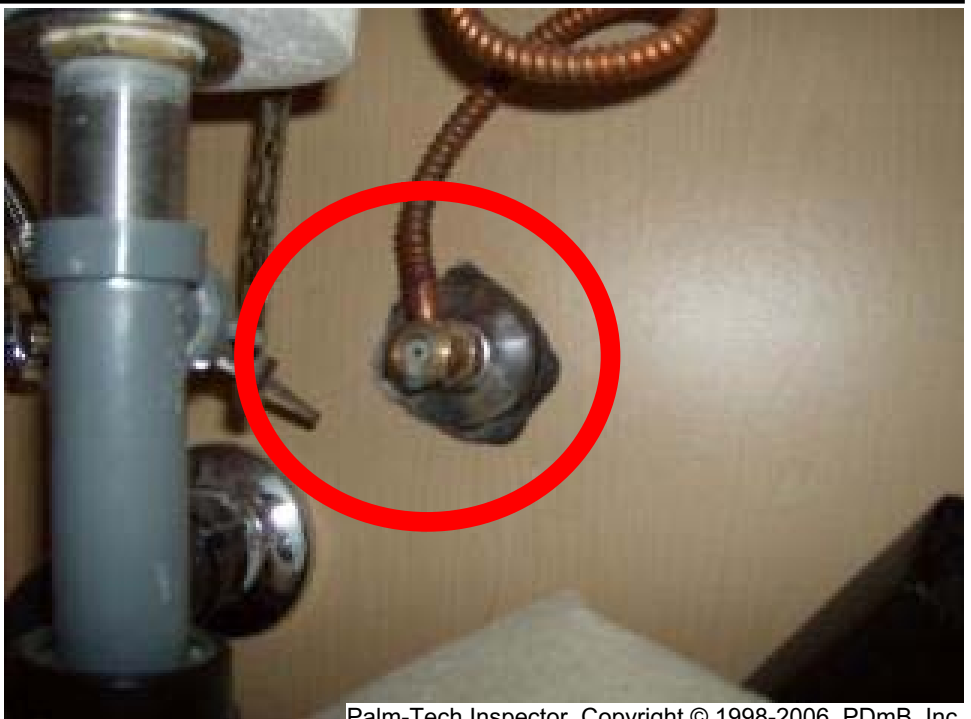
9. Master bath Bathroom Faucets/Traps:
Single handle sink faucet(s)
& ABS trap(s) Shutoff valve
missing handle, A licensed
plumber is recommended to
evaluate and estimate repairs

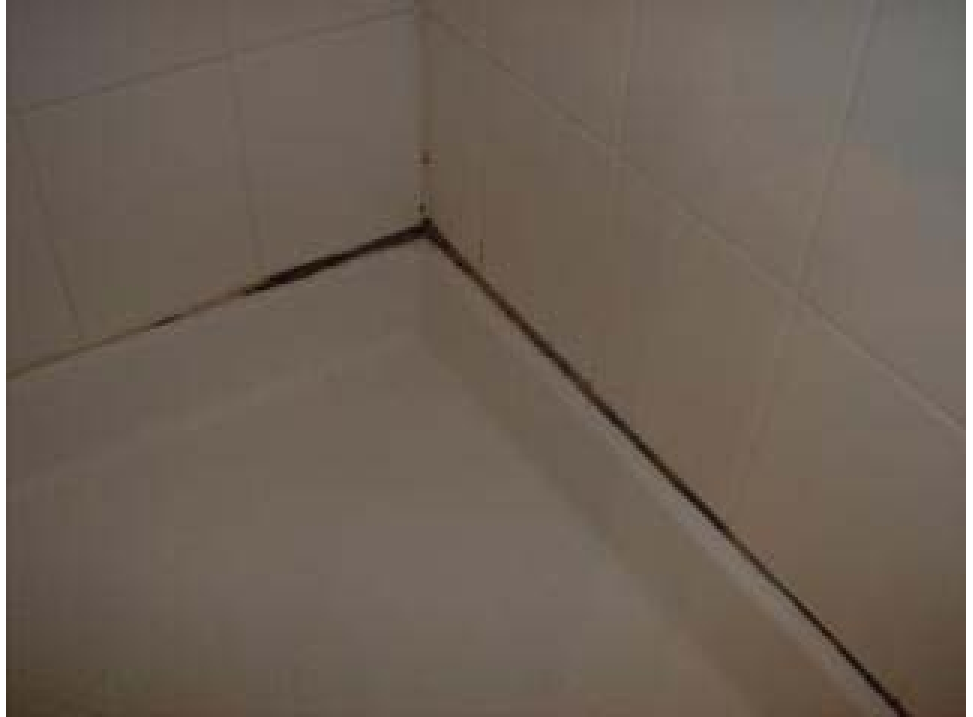
Shower/Surround: Fiberglass pan,
Ceramic tile surround [Replace
old caulking at the shower
pan](#)

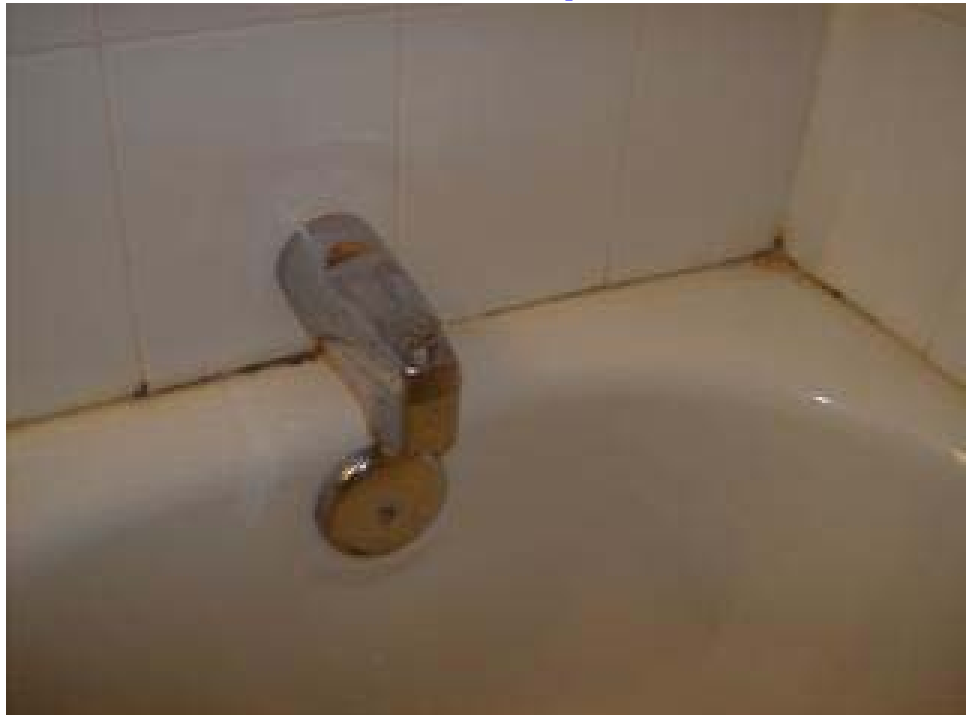
12. Main hall bath Bathroom Tub/Surround:
Porcelain on steel tub,
Ceramic tile surround [Replace
caulking](#)

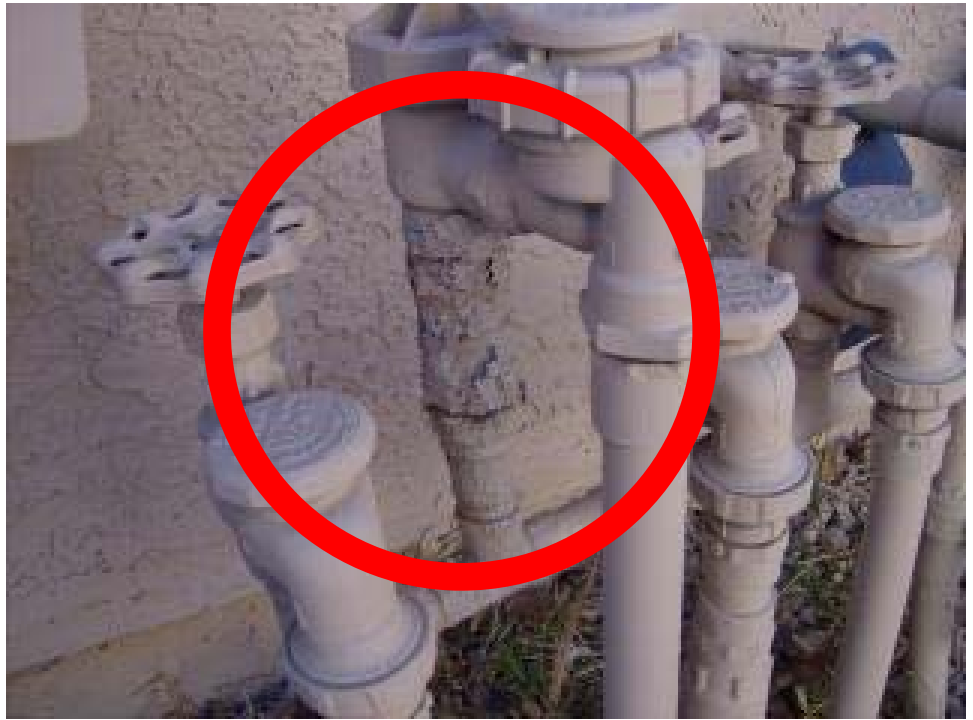
13. Service Line: Copper **Leaking,**
Recommend repair by a
qualified technician

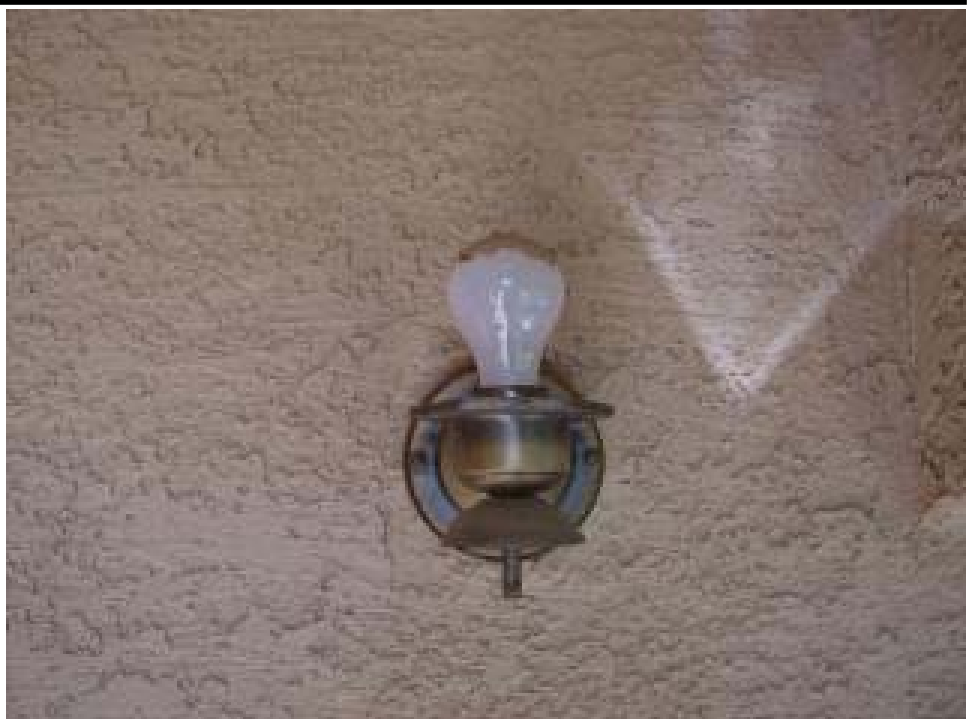
14. Exterior Lighting: Surface mounted
Missing globe

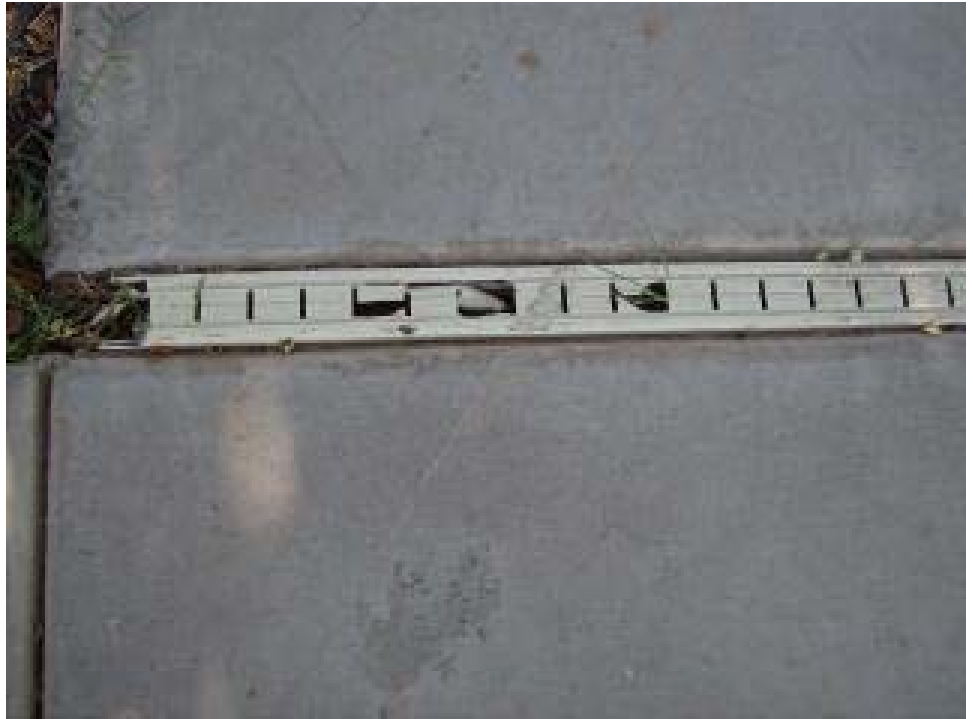
1. Walks: Concrete, Flagstone
Broken drain trough causing a trip hazard, A qualified contractor is recommended to evaluate and estimate repairs

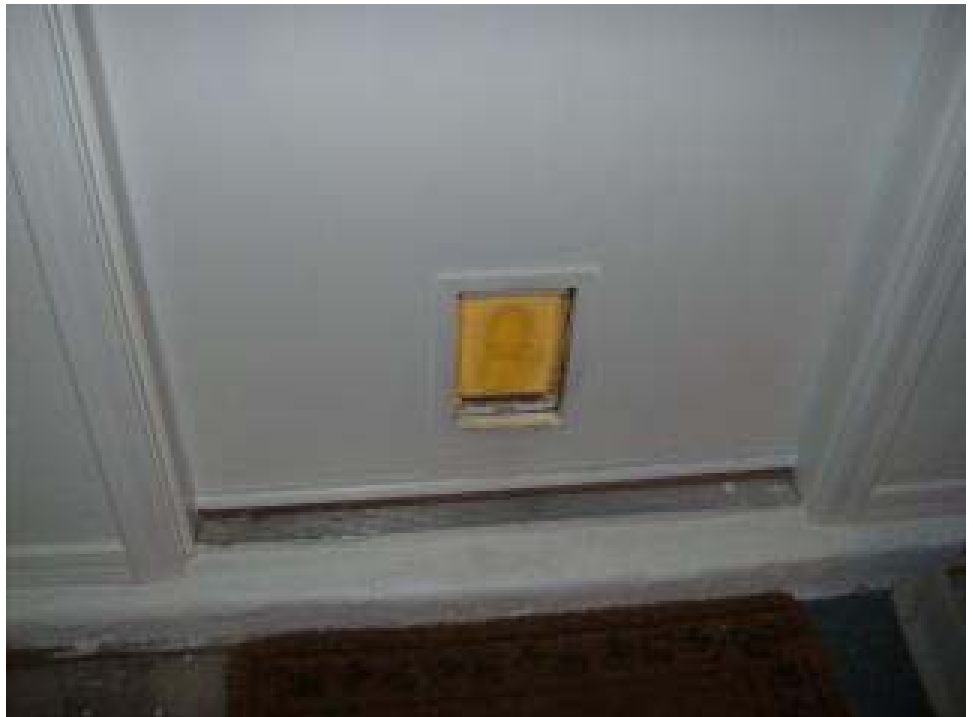
3. Northwest, Front Garage Door to house self closing & latching? Yes Door to house has a pet door cut in to it, A qualified contractor is recommended to evaluate and estimate repairs

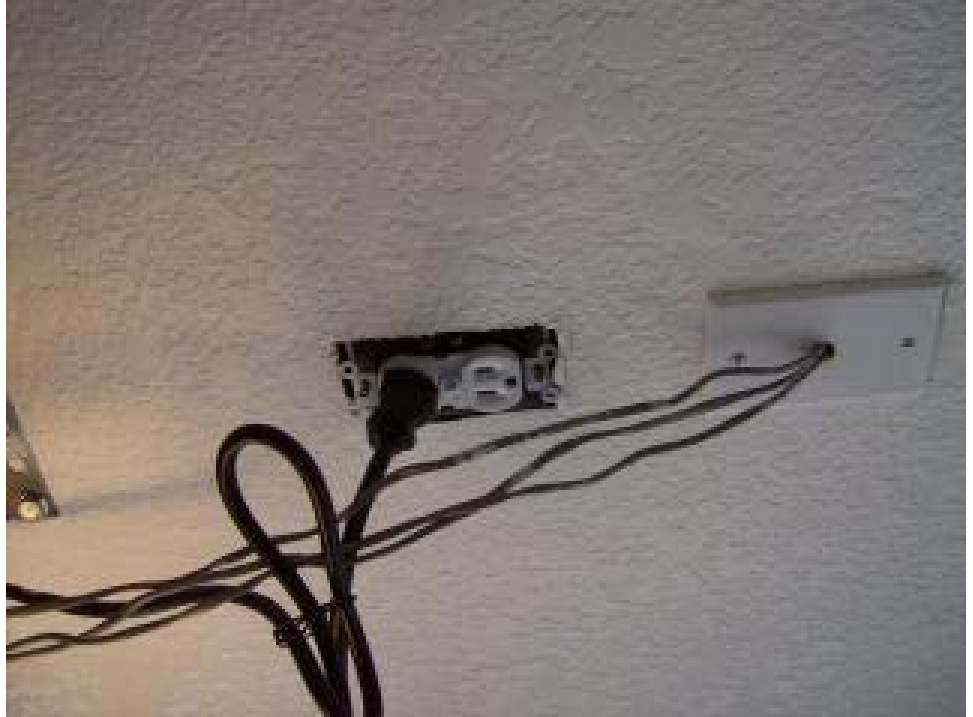
4. Northwest, Front Garage Electrical: 110
VAC lighting & GFCI outlet
circuits **Missing**
outlet/switch cover plates

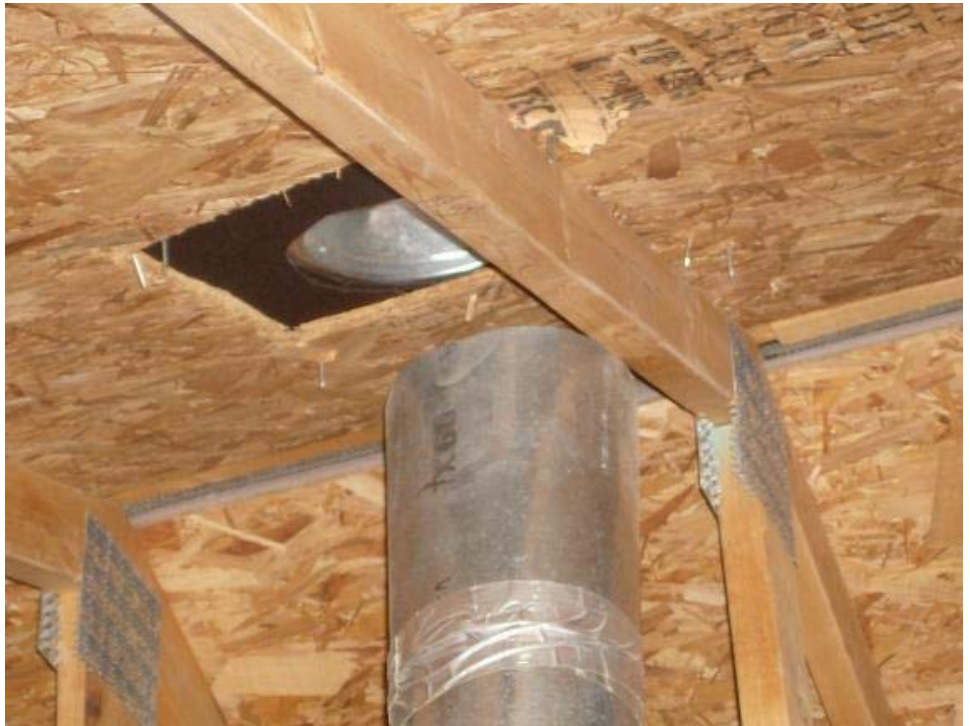
8. Laundry Room Attic Kitchen Venting Not vented through the roof

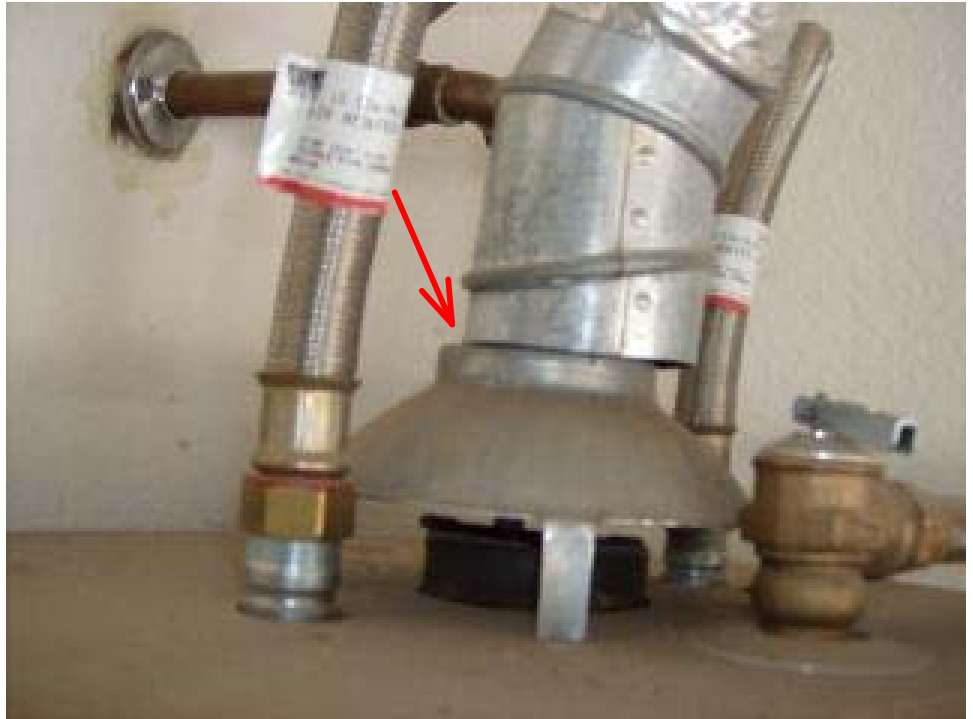
10. Garage Water Heater Flue Pipe:
Single wall, Double wall Flue
pipe not connected at top of
water heater

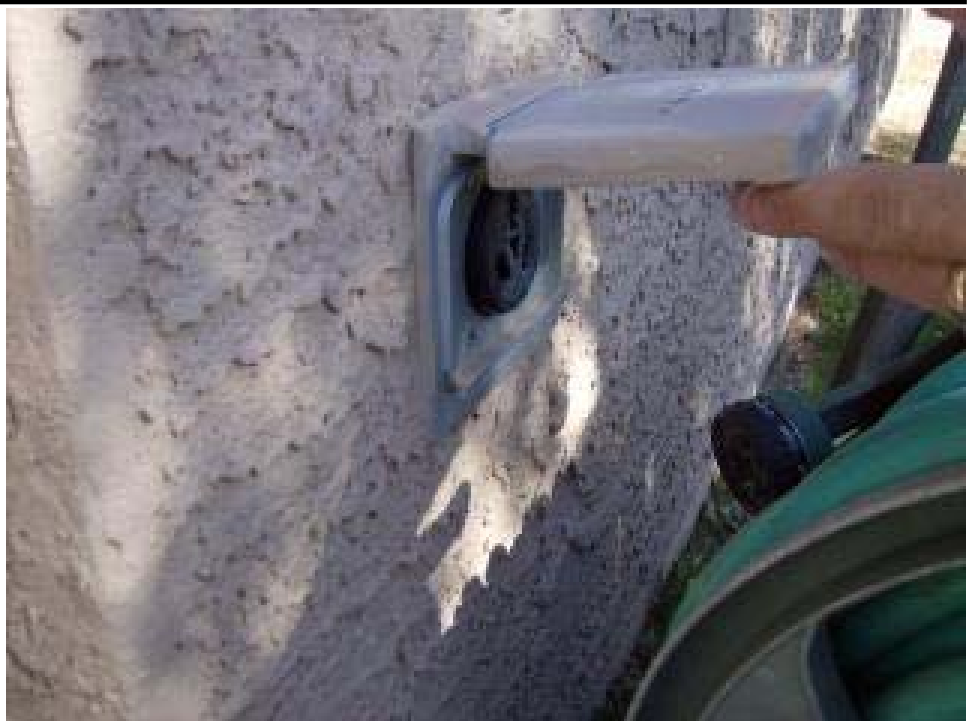
11. Exterior Electric Outlets: GFCI
protected, Not GFCI protected
Non-GFCI outlet at southeast
240 volt outlet, Recommend
repair by a qualified
technician
